Mechanical Cracking

The Major Cause for Multilayer Ceramic Capacitor Failures

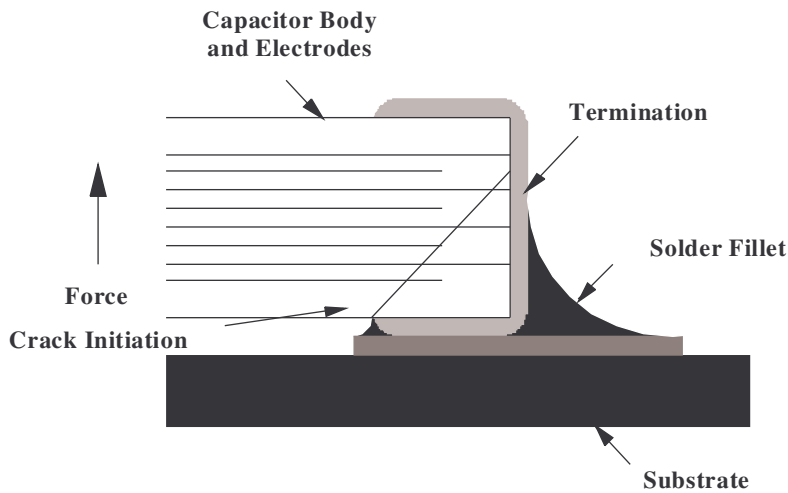
Fig 1. Mechanical Crack

Due to its brittle nature, multilayer ceramic capacitors are more prone to excesses of mechanical stress than other components used in surface mounting. One of the most common causes of capacitor failures is directly attributable to bending of the printed circuit board (PCB) after solder attachment. Excessive bending will create mechanical crack(s) within the ceramic capacitor. Mechanical cracks, depending upon severity, may not cause capacitor failure during the final assembly test. Over time moisture penetration into the crack can cause a reduction in insulation resistance and eventual dielectric breakdown leading to capacitor failure in service.

When mechanical cracking has been identified as the cause for capacitor failures the typical approach for customers is to review the production process for any obvious process stage including handling and transportation that may be bending the PCB. If no obvious stage is identified then the next step is to remove samples of capacitors from assemblies at different process stages and then subject the capacitors to sectioning/ internal examination to determine if the capacitors have been cracked. The shape of mechanical cracks is shown in Fig. 1.

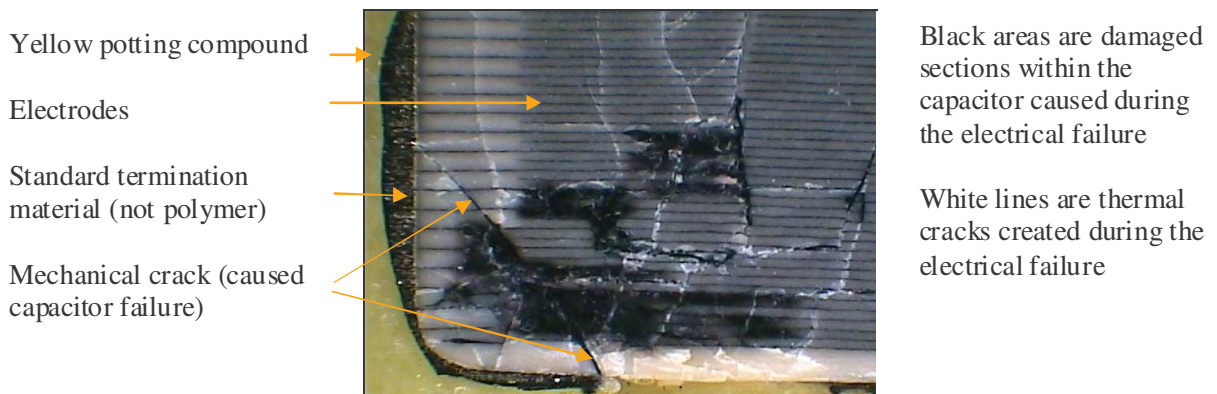
Example of capacitors issued by customers to Syfer for failure investigation:

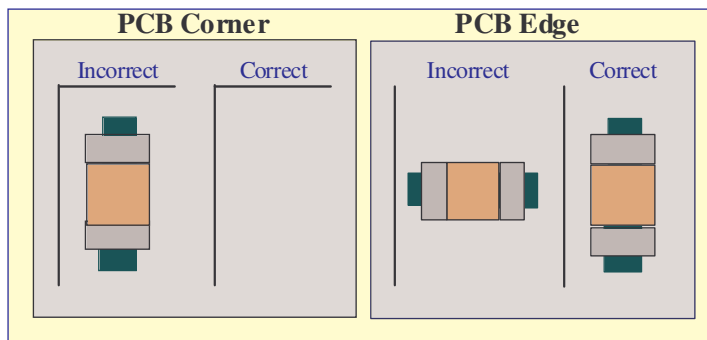
Capacitor placement not recommended in the corner of the PCB.

Recommended capacitor orientation with respect to PCB edge (denoted by black lines).

Note: Stress zone is typically within 5mm of PCB edge or fixing point.

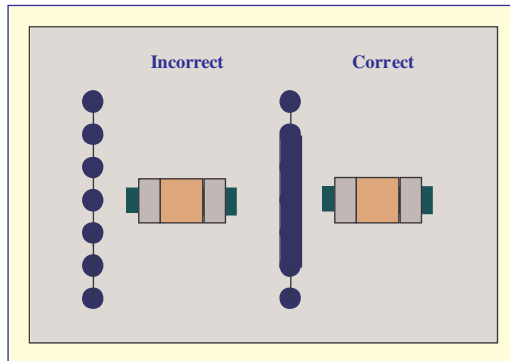
Use of PCB slots

Using a slot along the depanelisation edge reduces the level of stress exerted onto the capacitor by approximately 50%.

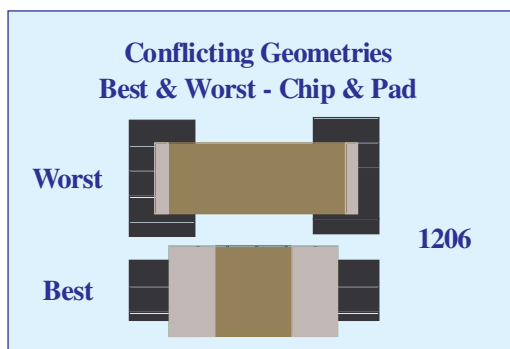
- Solder pad/ land sizes.

Reducing the pad/ land size can reduce the level of stress exerted onto the capacitor by approximately 50%.
